**CORROSION CONDITION SURVEY  
OF U1020 MONTANA AVENUE OVERPASS-BILLINGS  
FOR  
MONTANA DEPARTMENT OF TRANSPORTATION  
WJE No. 2000.2547  
November 27, 2000**

CORROSION CONDITION SURVEY  
OF U1020 MONTANA AVENUE OVERPASS-BILLINGS  
FOR  
MONTANA DEPARTMENT OF TRANSPORTATION  
WJE No. 2000.2547  
November 27, 2000

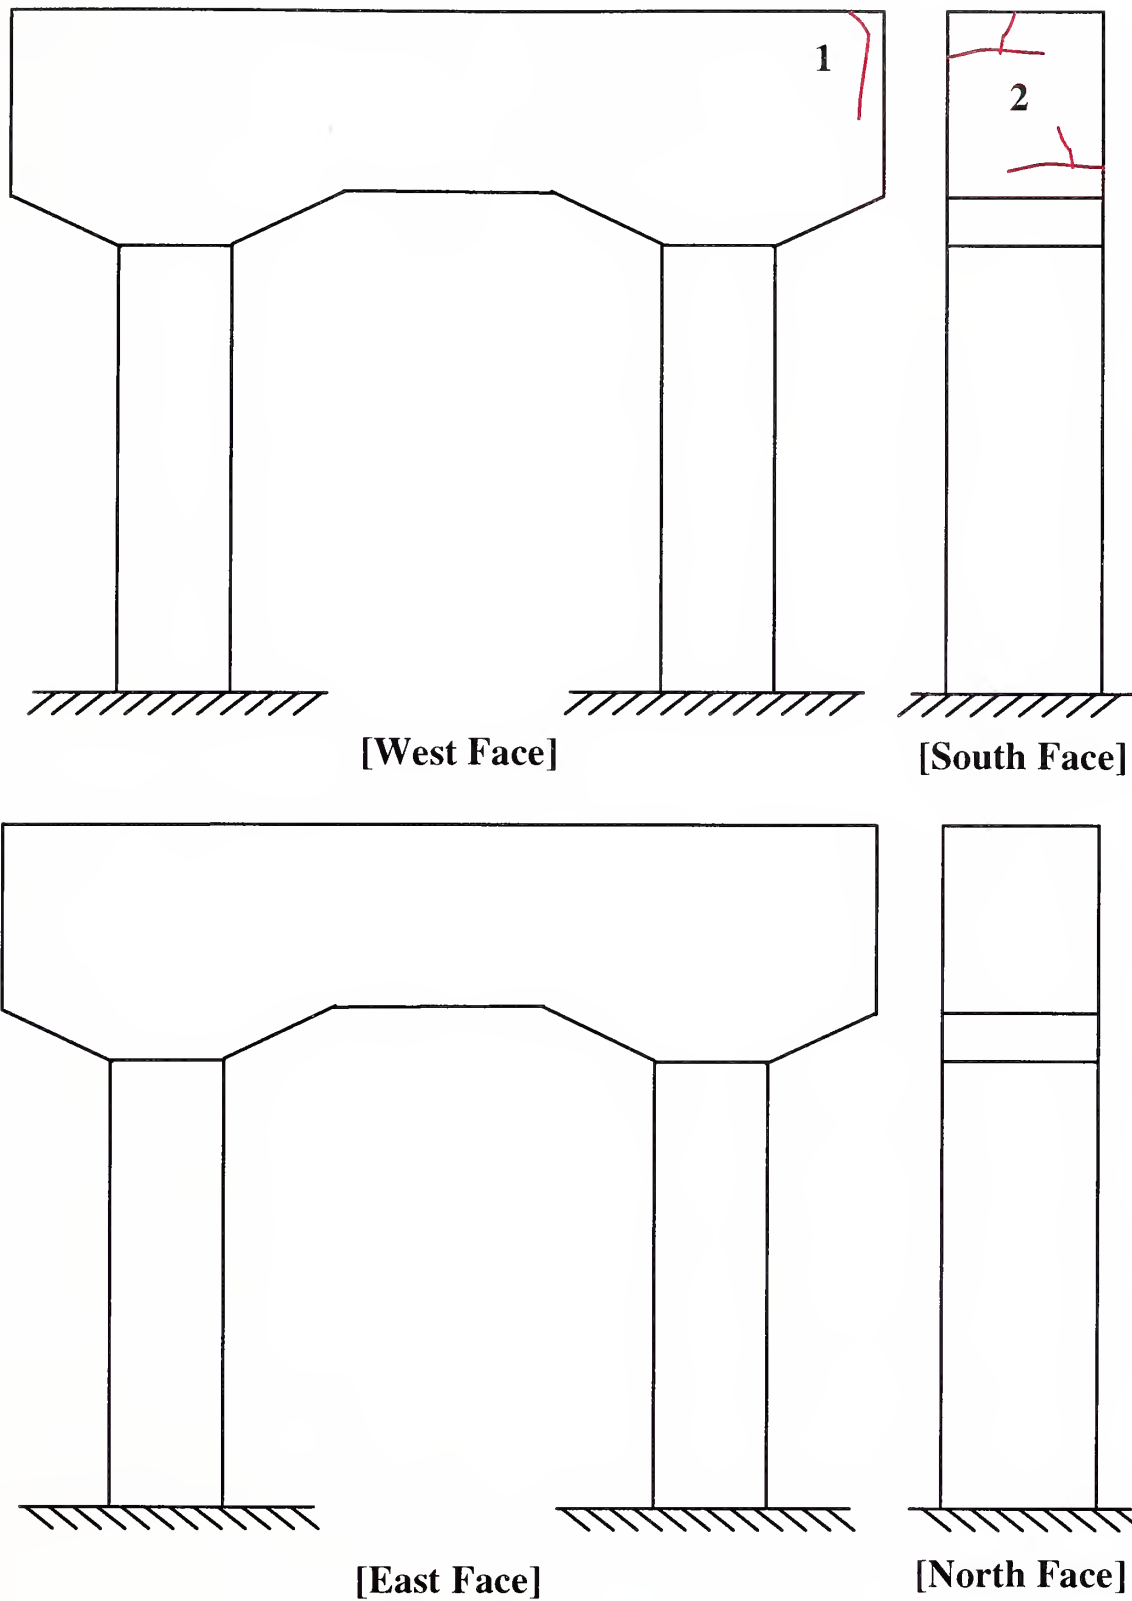
**Figure 3A. Condition of Bent No. 4 (East Bound).**

Damage	Location	Face	Description of Damage (No.)	Leakage Condition: No leakage
	Cap	West	A crack (1)	
	Cap	North	Cracks (2)	
				Test Performed: None

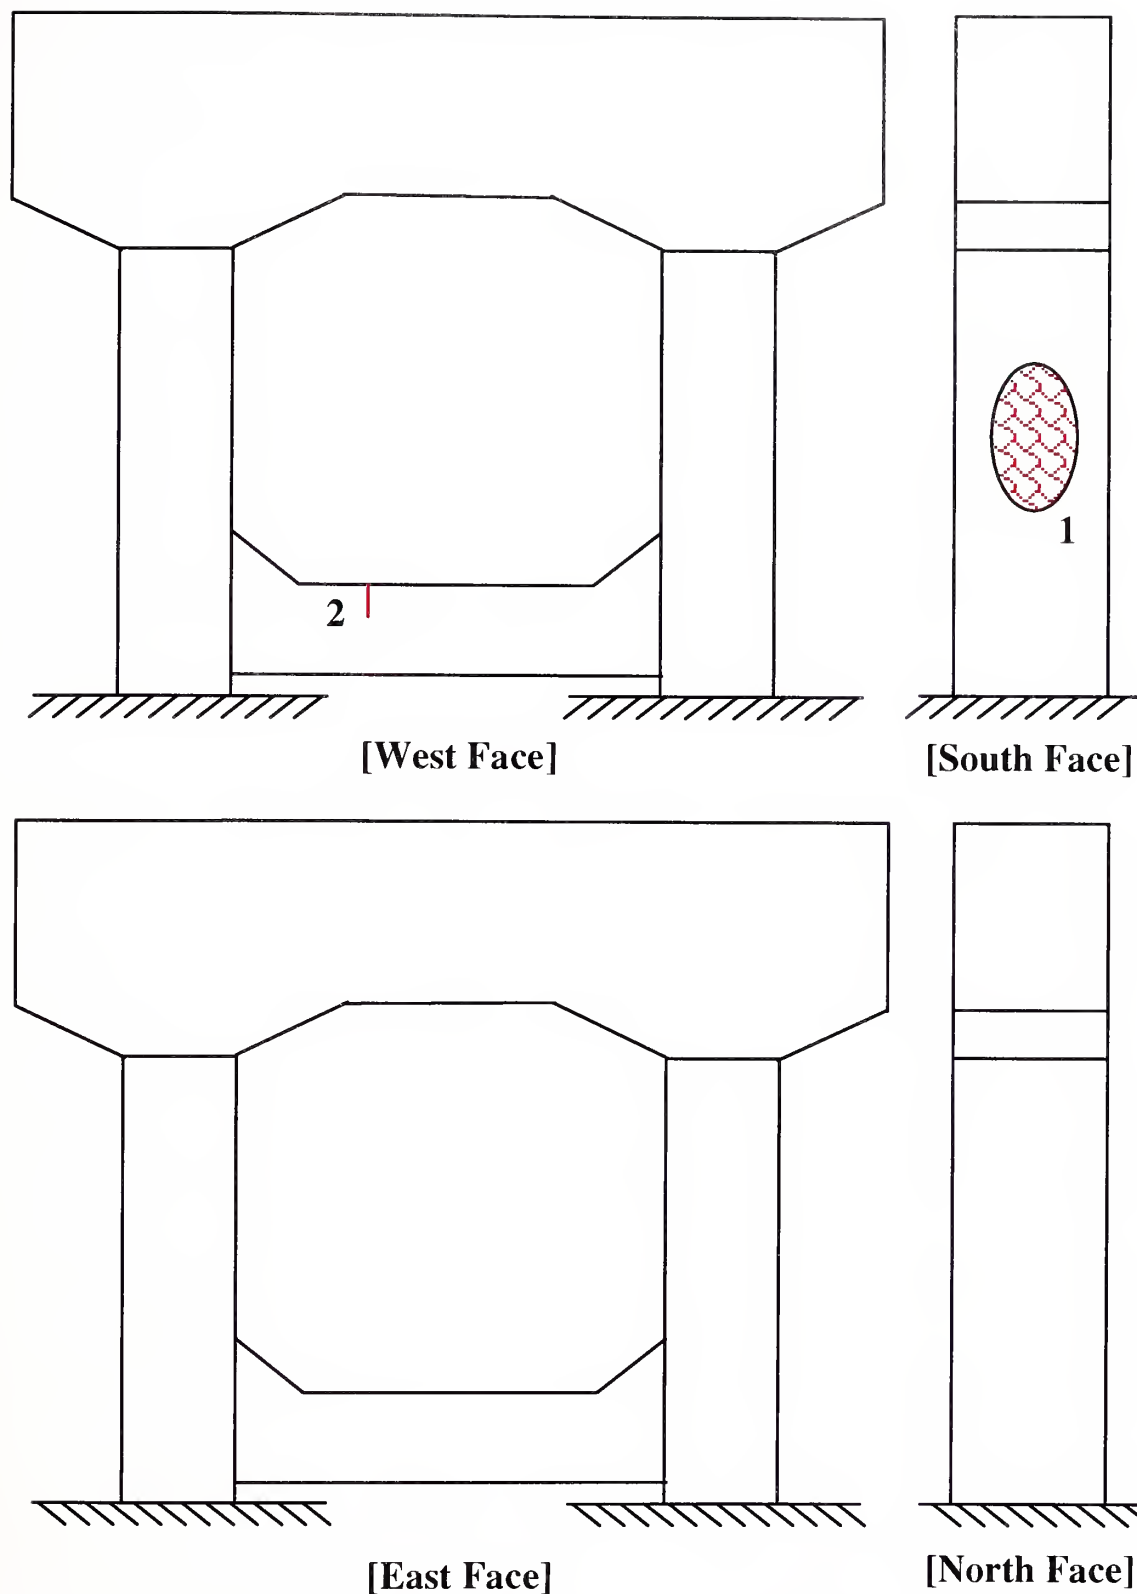
**Figure 20A. Condition of Bent No. 21 (East Bound).**

Damage	Location	Face	Description of Damage (No.)	Leakage Condition: No leakage but dry stains
	S. Col.	South	A crack and dry stains (1)	
	Cap	West	A crack (2)	Test Performed: None
	Cap	East	A crack (3)	
	S. Col.	East	A crack along the edge(4)

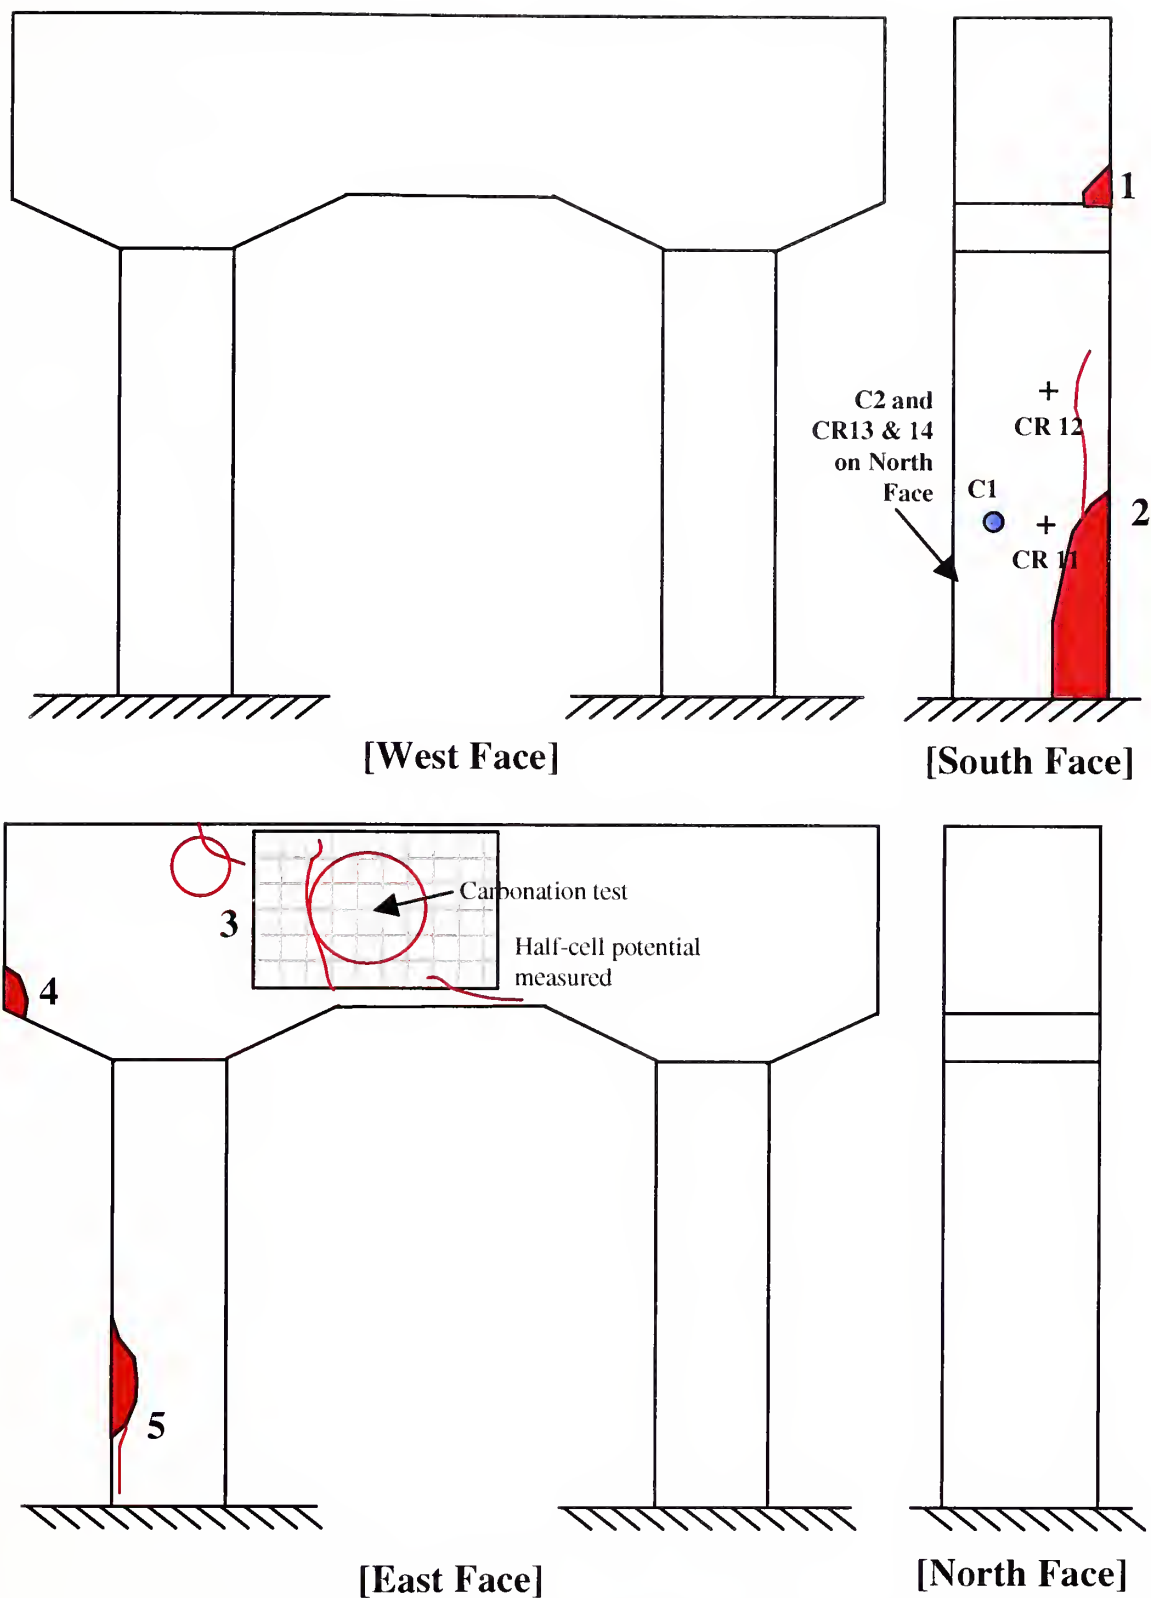
**Figure 24A. Condition of Bent No. 25 (East Bound).**

Damage	Location	Face	Description of Damage (No.)	Leakage Condition: Active leakage under beams 2-5 Test Performed: - CR 11-14 - Cores 1-2 - Carbonation Test at 3 - Half-Cell Potential
	Cap	South	Small spall exposing a rebar (1)	
	S. Col.	South	Large spall and a crack (2)	
	Cap	East	Two delamination & 3 cracks (3)	
	Cap	East	Small spall (4)	
	S. Col.	East	Medium spall and a crack (5)

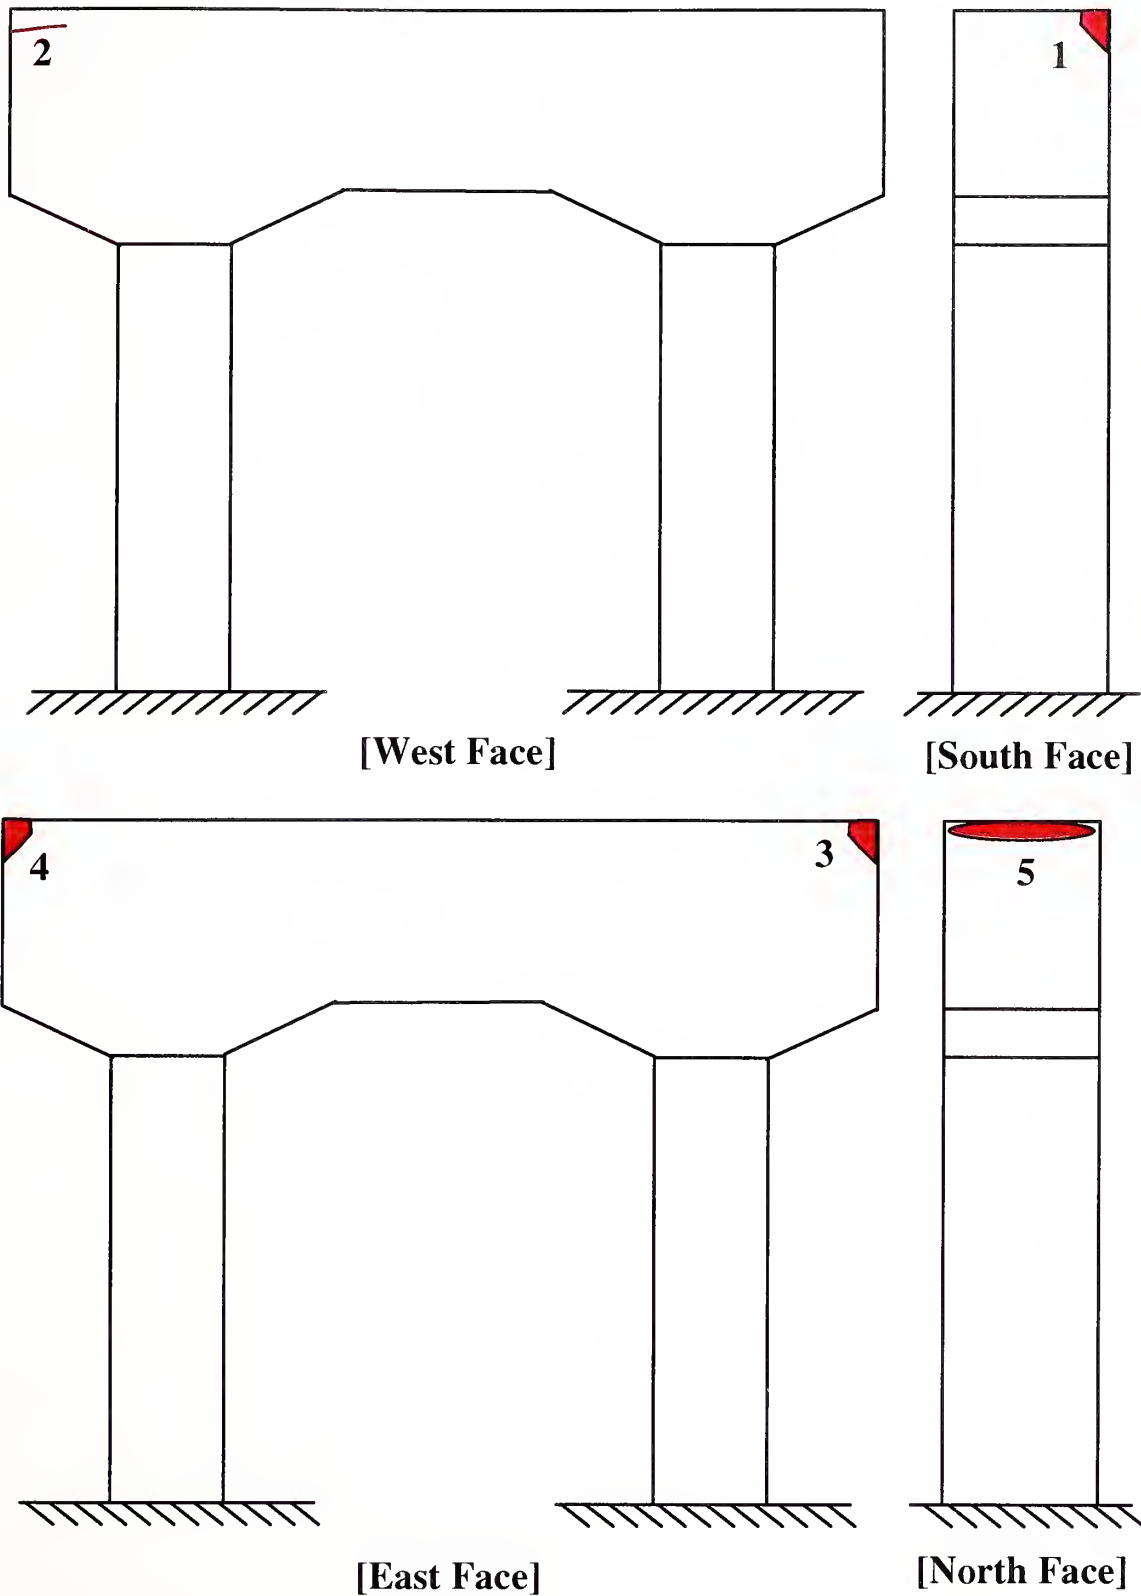
**Figure 31A. Condition of Bent No. 32 (East Bound).**

Damage	Location	Face	Description of Damage (No.)	Leakage Condition: No leakage but moist
	Cap	South	A spall and a crack (1)	
				Test Performed: None

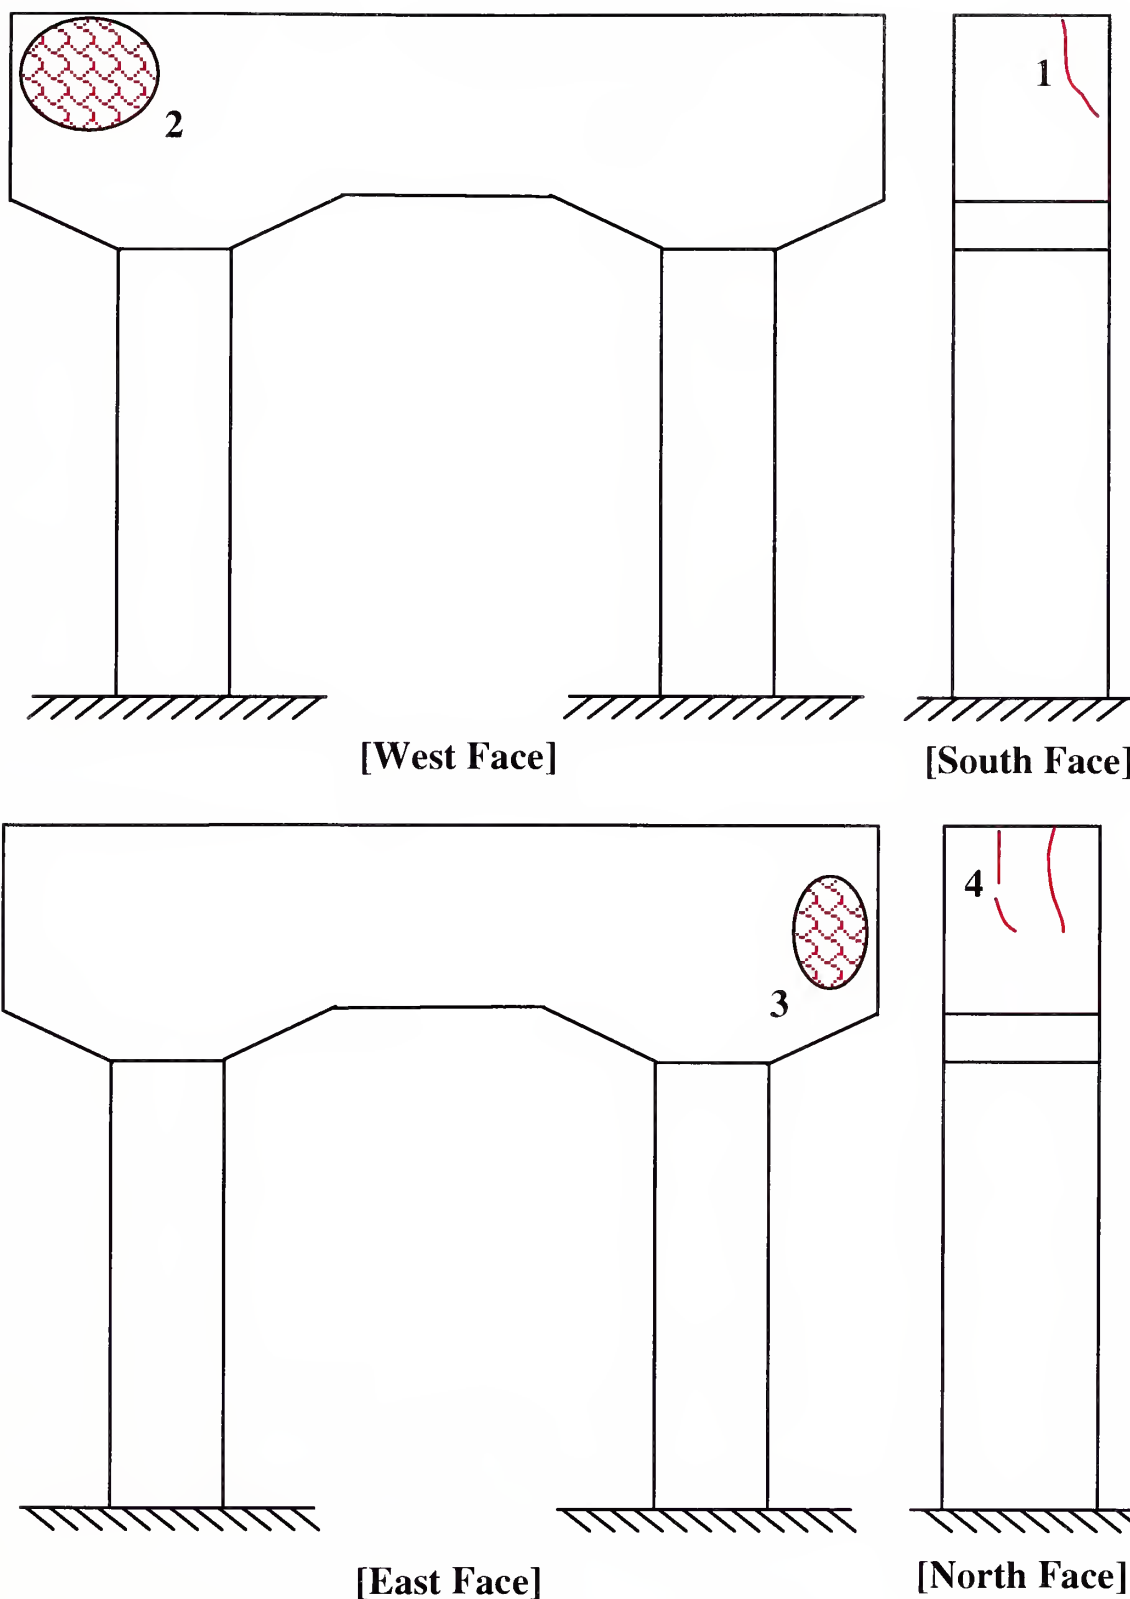
**Figure 35A. Condition of Bent No. 5 (West Bound).**

Damage	Location	Face	Description of Damage (No.)	Leakage Condition: Moist below beams 1-2  Test Performed: None
	Cap	South	A crack (1)	
	Cap	West	Pattern cracking (2)	
	Cap	East	Pattern cracking (3)	
	Cap	North	Three cracks (4)

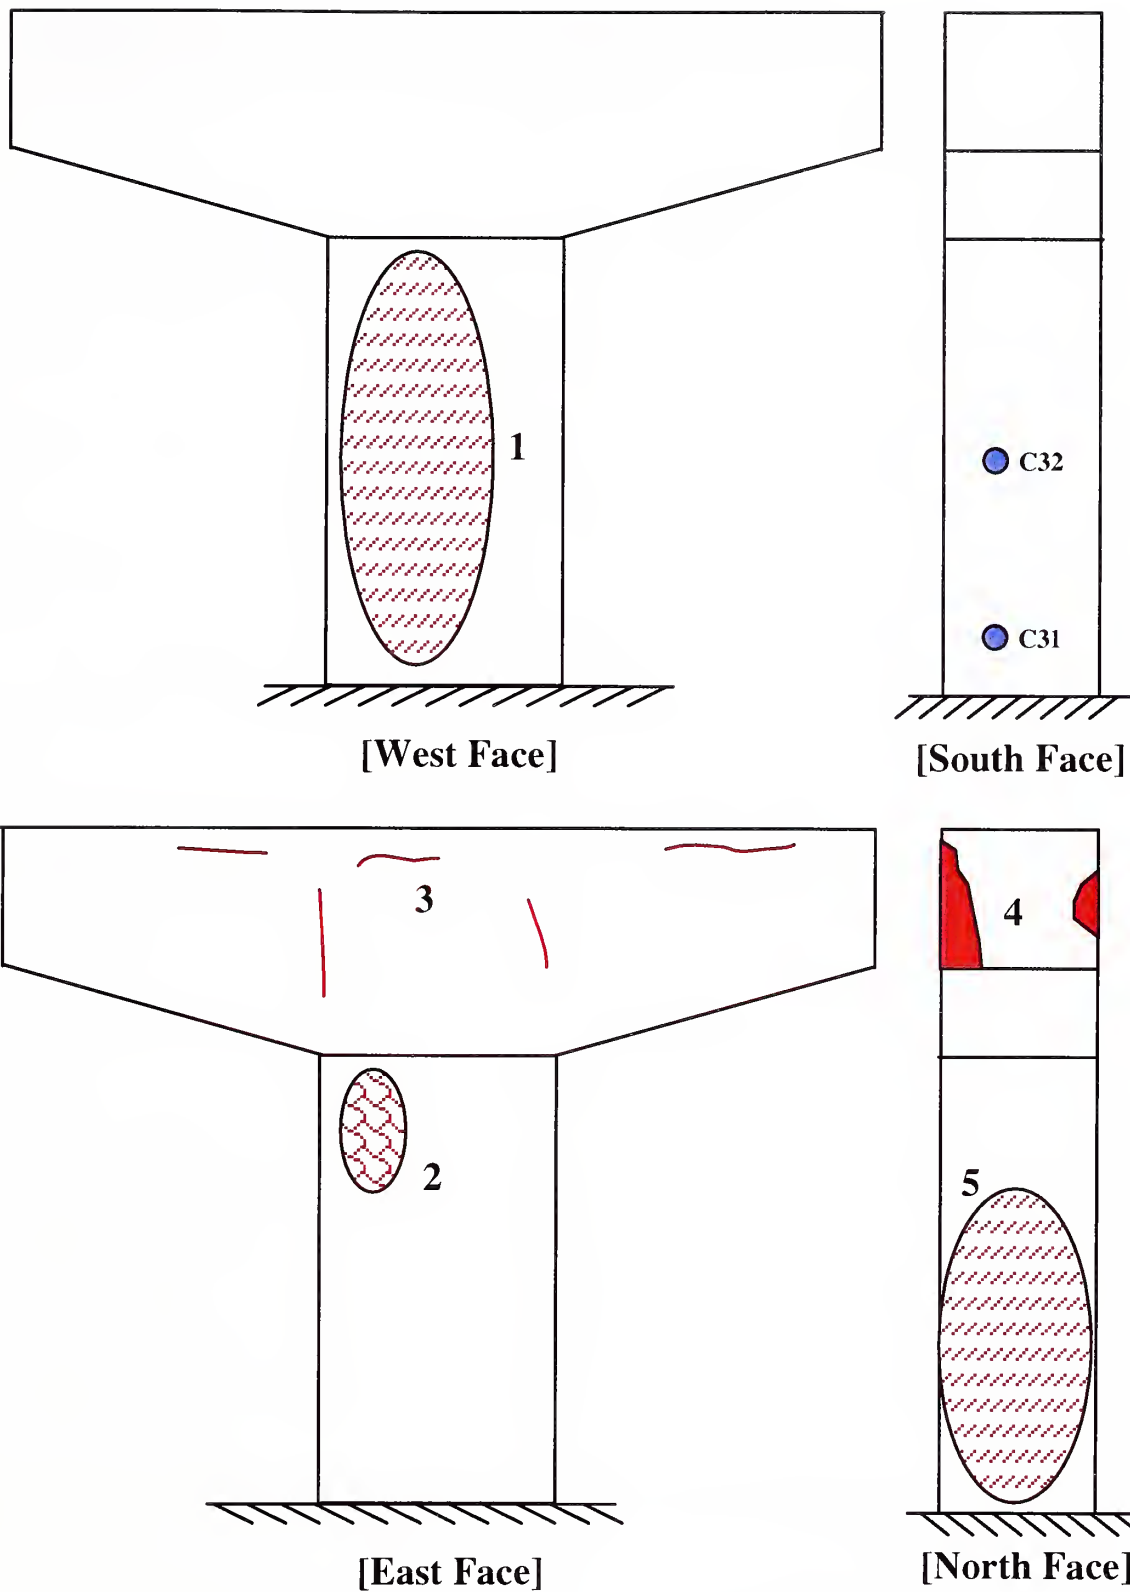
**Figure 38A. Condition of Bent No. 8 (West Bound).**

Damage	Location	Face	Description of Damage (No.)	Leakage Condition: Active leakage below beams 1-2, 2-3, 3-4  Test Performed: - Cores C31 and C32
	Column	West	Multiple cracks (1)	
	Column	East	Pattern cracking (2)	
	Column	East	Five cracks (3)	
	Column	North	Two spalls (4)	
	Column	North	Multiple cracks (5)

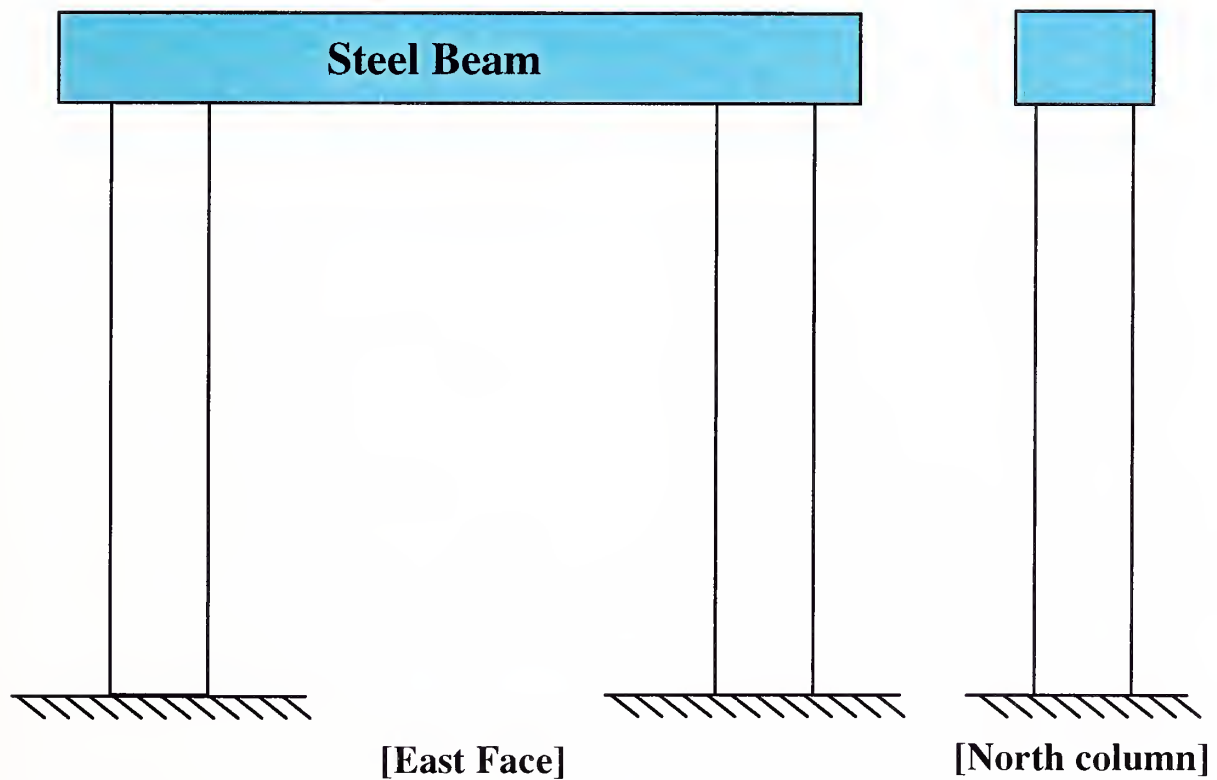
Figure 39A. Condition of Bent No. 9 (West Bound).

Damage	Location	Face	Description of Damage (No.)	Leakage Condition: No deck above and exposed  Test Performed: None
	Column	Circular	Multiple cracks on NW and W sides (1): Photo taken

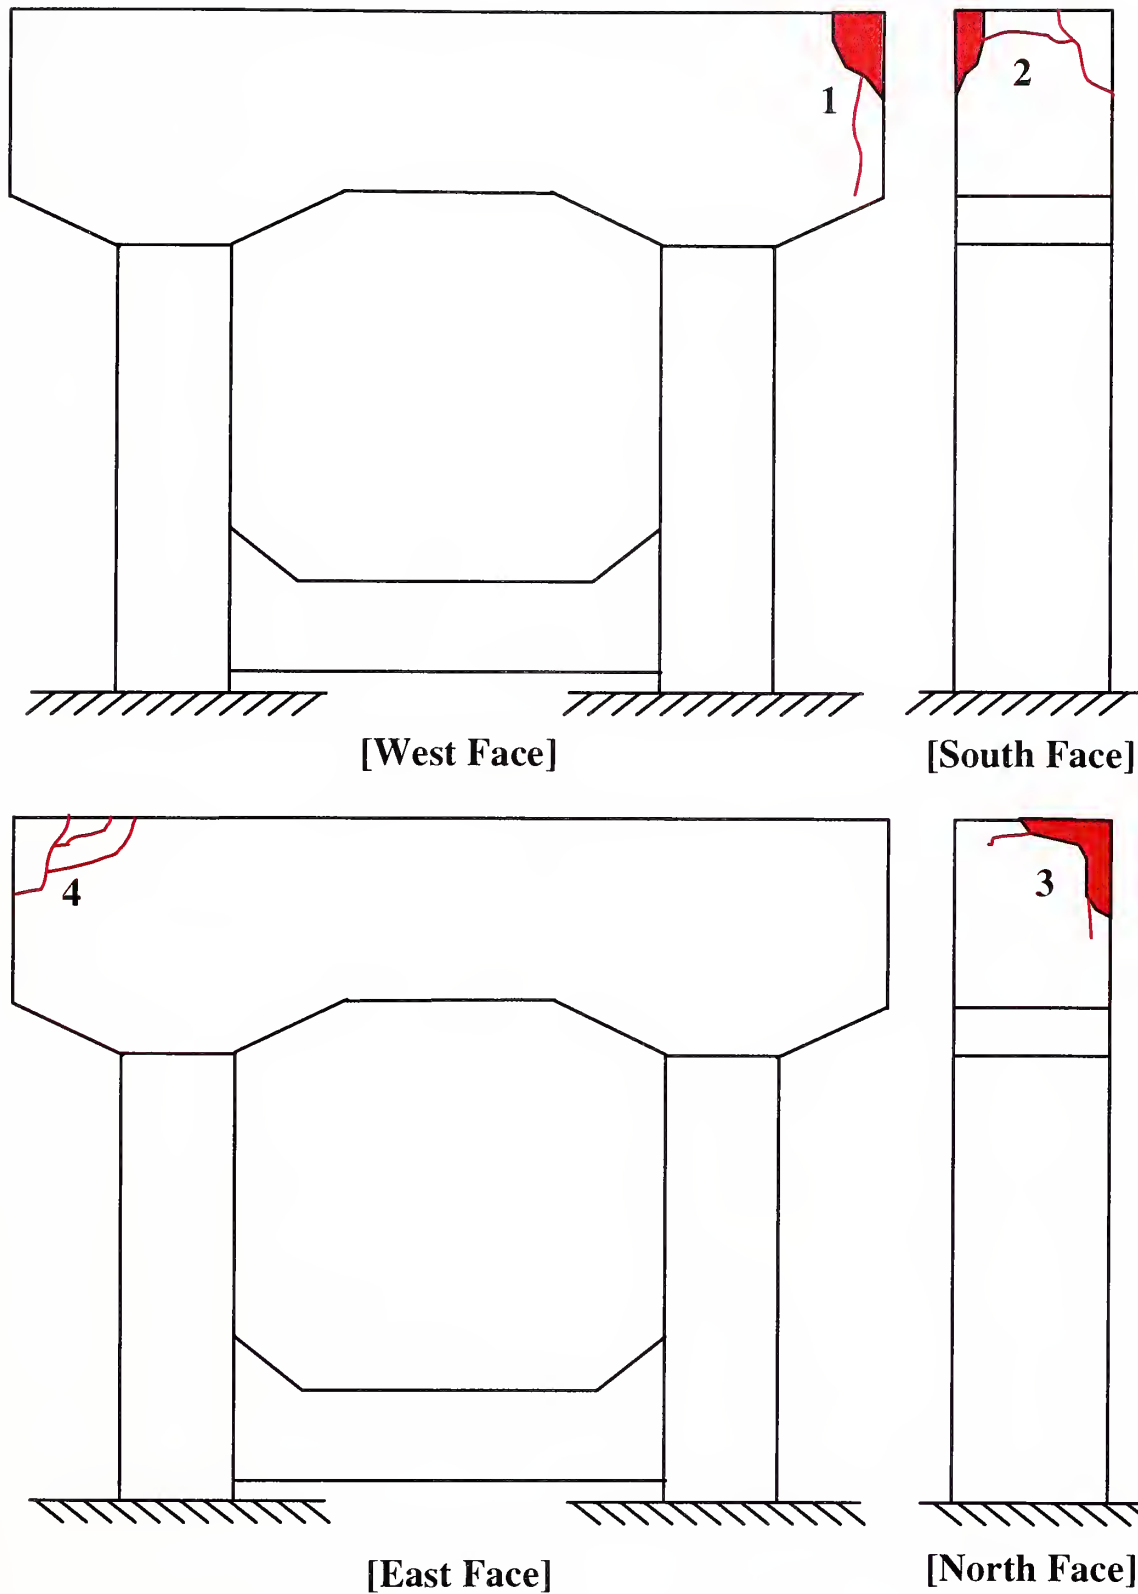
**Figure 47A. Condition of Bent No. 17 (West Bound).**

Damage	Location	Face	Description of Damage (No.)	Leakage Condition: No leakage but moist  Test Performed: None
	Cap	West	Spall and a crack (1)	
	Cap	South	Spall and two cracks (2)	
	Cap	North	Spall and two cracks (3)	
	Cap	East	Three cracks (4)

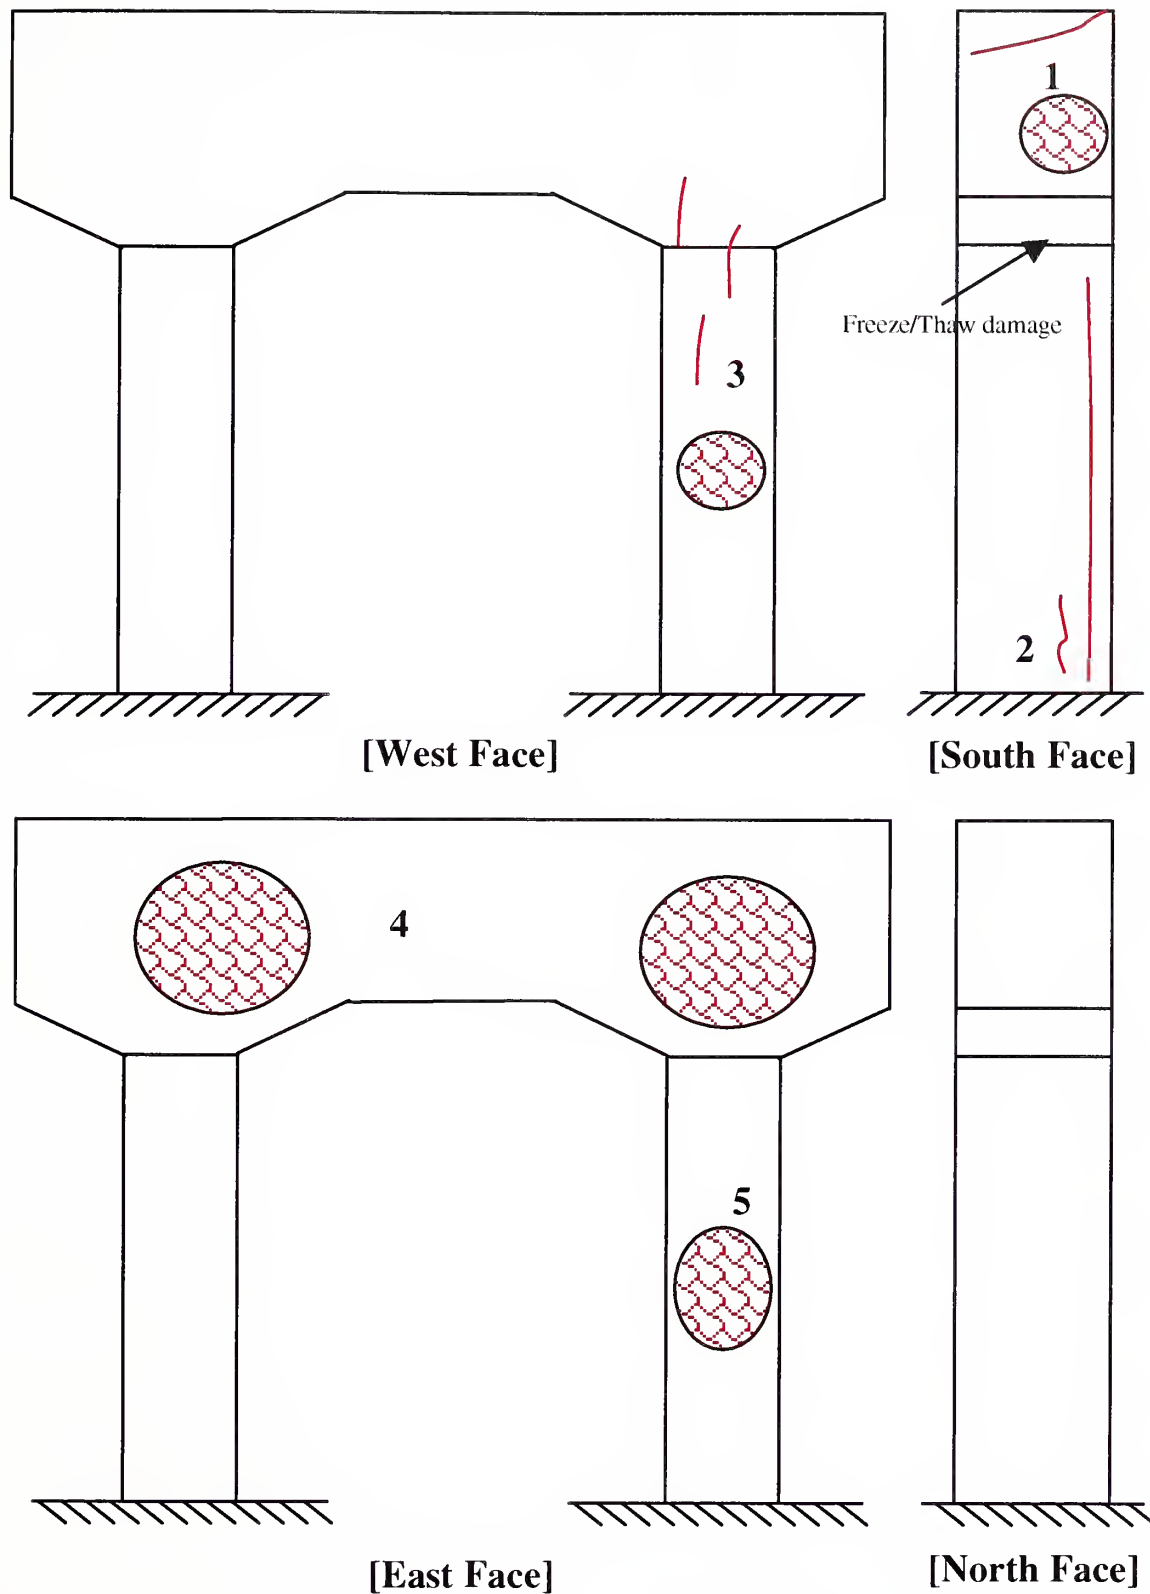
**Figure 57A. Condition of Bent No. 27 (West Bound).**

Damage	Location	Face	Description of Damage (No.)	Leakage Condition: Active leakage on south column  Test Performed: None
	Cap	South	A crack and pattern cracking (1)	
	S. Col.	South	Two cracks (2)	
	S. Col.	West	3 cracks and pattern cracking (3)	
	Cap	East	Two pattern cracking areas (4)	
	N. Col.	East	Pattern cracking (5)

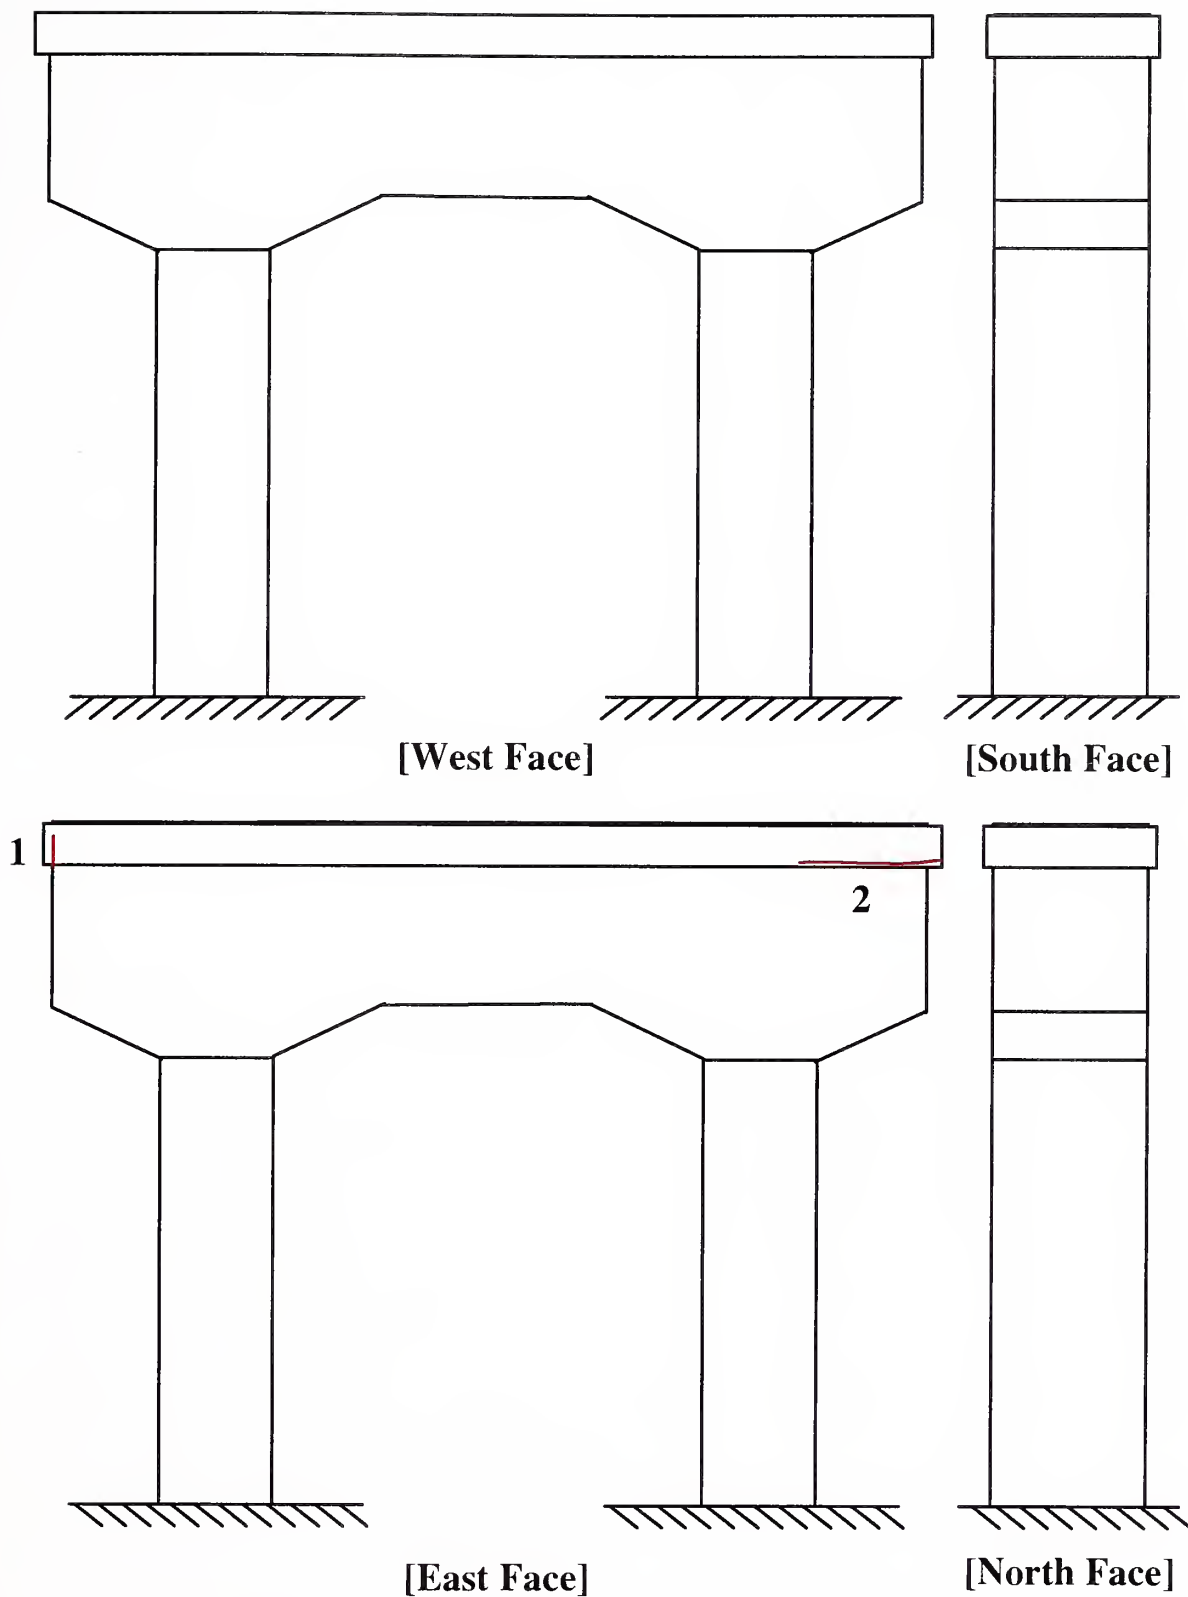
Figure 63A. Condition of Bent No. 33 (West Bound).

Damage	Location	Face	Description of Damage (No.)	Leakage Condition: No leakage but moist below beams 1-5  Test Performed: None
	Cap	East	A crack on top cap (1)	
	Cap	East	A crack on top cap (2)
